SECTION 32 PROGRAM
STREAMBANK EROSION CONTROL
EVALUATION AND DEMONSTRATION
WORK UNIT 2-EVALUATION OF EXISTING
BANK PROTECTION

FIELD INSPECTION OF THE MILL CREEK
MIDFLOODWAY GABION BARRIER IN THE
LOS ANGELES DISTRICT

April 1980
Inspection Report 9

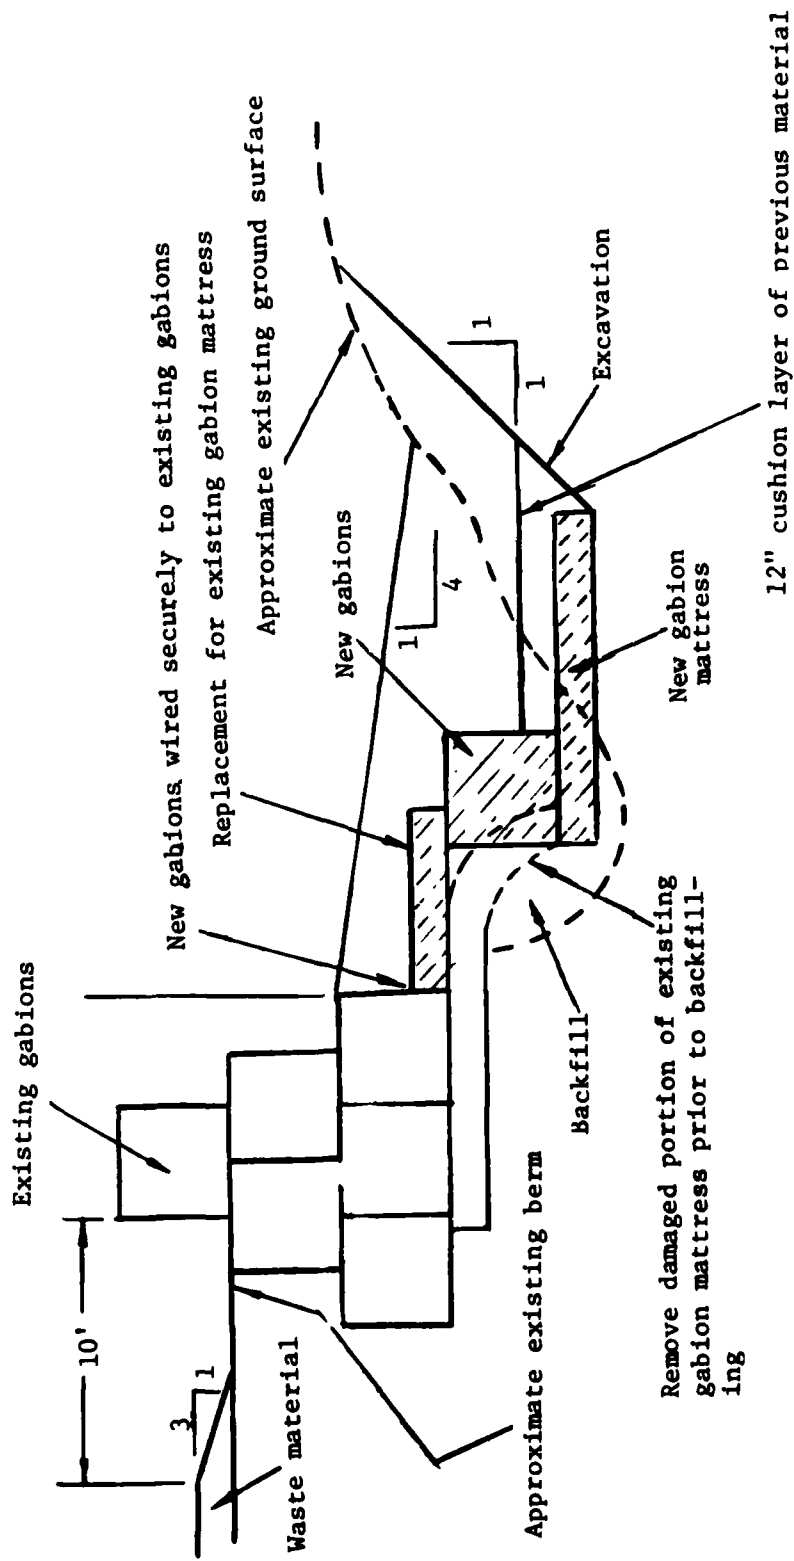
Figure 11. Modification to gabion barrier immediately downstream from Garnet Street Bridge in 1970 after the 1969 Mill Creek floods

19. In 1970 the foundation of the gabion barrier downstream from Garnet Street Bridge was modified (as shown in Figure 11). Additionally, two new sections of the gabion barrier were placed immediately upstream from Garnet Street Bridge to divert flows away from the levees and under the bridge. The locations of these upstream gabions and a cross-sectional view are shown in Figures 3 and 12, respectively. The farthest upstream section is 675 ft long, and the section located 300 ft upstream from Garnet Street Bridge is 500 ft long. The cost (1970) of modification to the existing gabions and construction of the new section of the barrier upstream from the bridge was \$79,000.

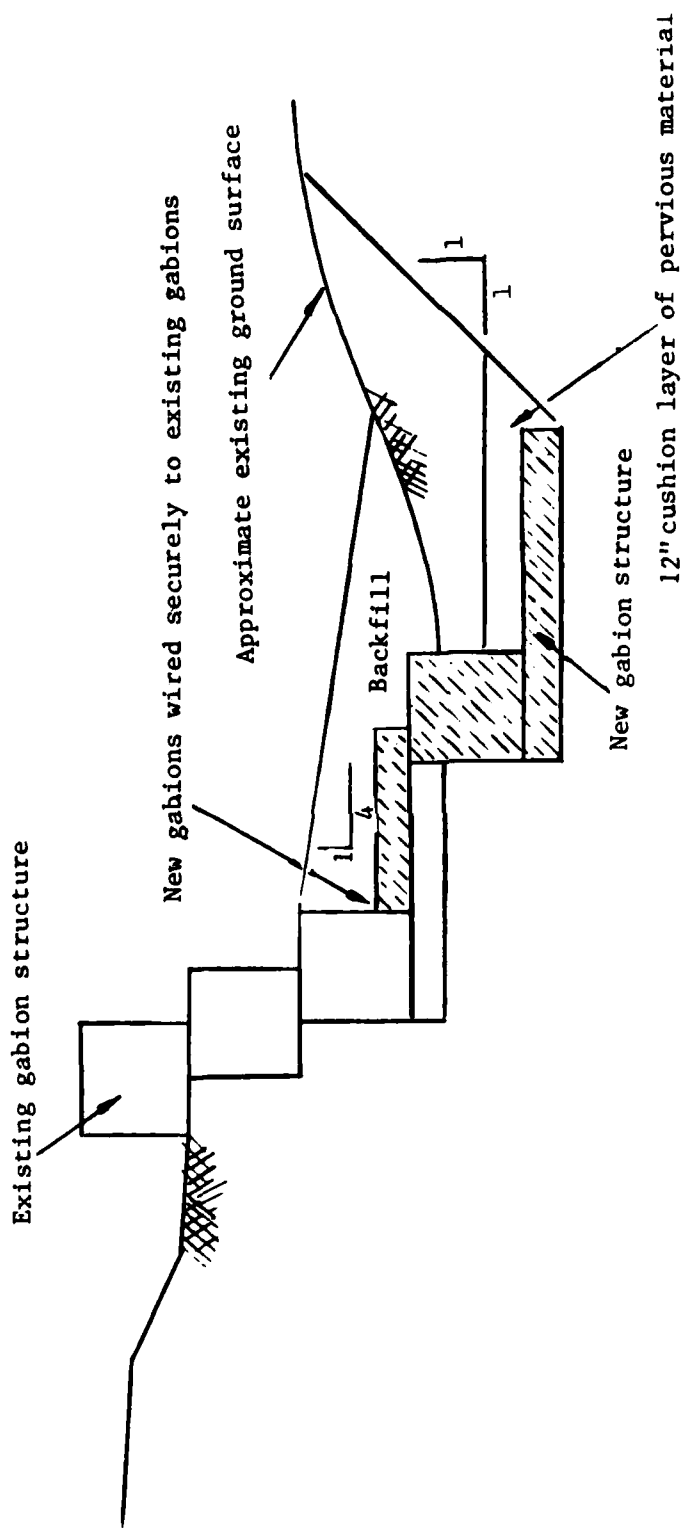
21. High flows resulting from the storms of 8-14 February and 3-6 March 1978* caused some deflection of 200 ft of the farthest upstream section of the gabion barrier. Figure 13 shows the modification designed to maintain the integrity of this portion of the gabion barrier as constructed in September 1978. There was no deflection of the section of the gabion barrier downstream from Garnet Street Bridge.

Figure 13. Modification to farthest upstream section of the midfloodway gabion barrier as constructed in September 1978 (paragraph 21)
